Report on investigation into System Disturbance of August 5th 2005

11th December 2005

Final Report on System Incident of August 5th 2005

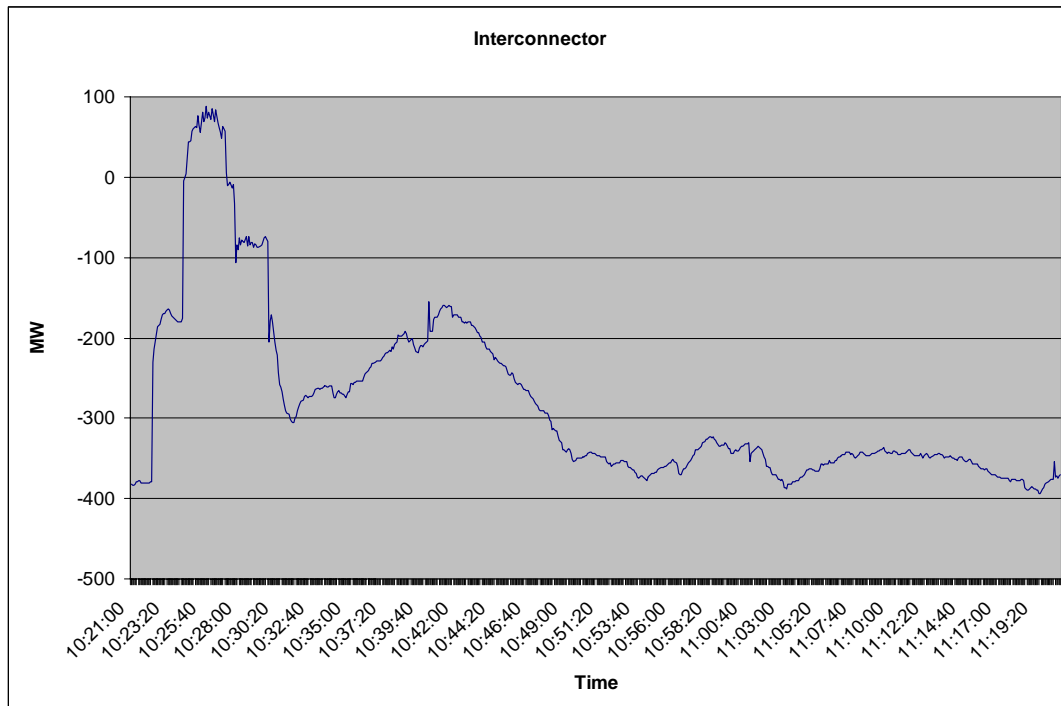
Graph showing the flow on the north-south interconnector.

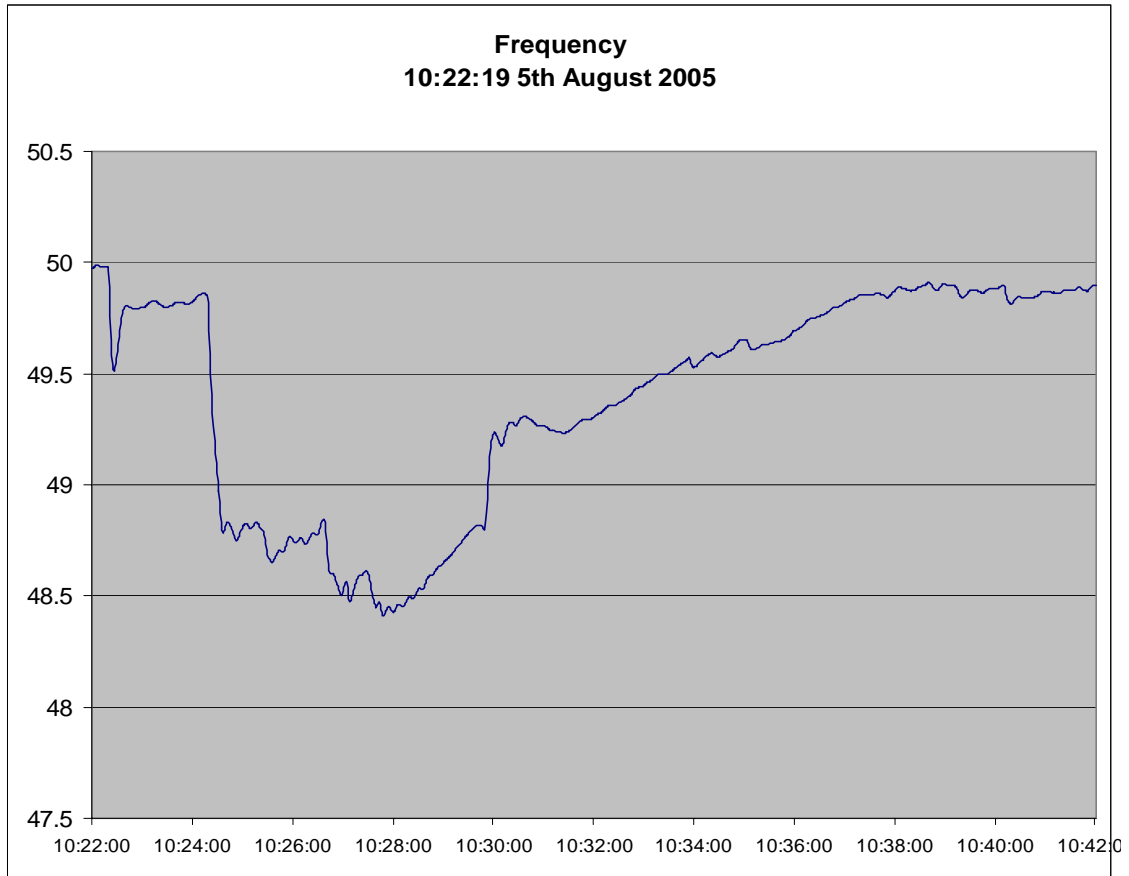
Graph showing the power system frequency

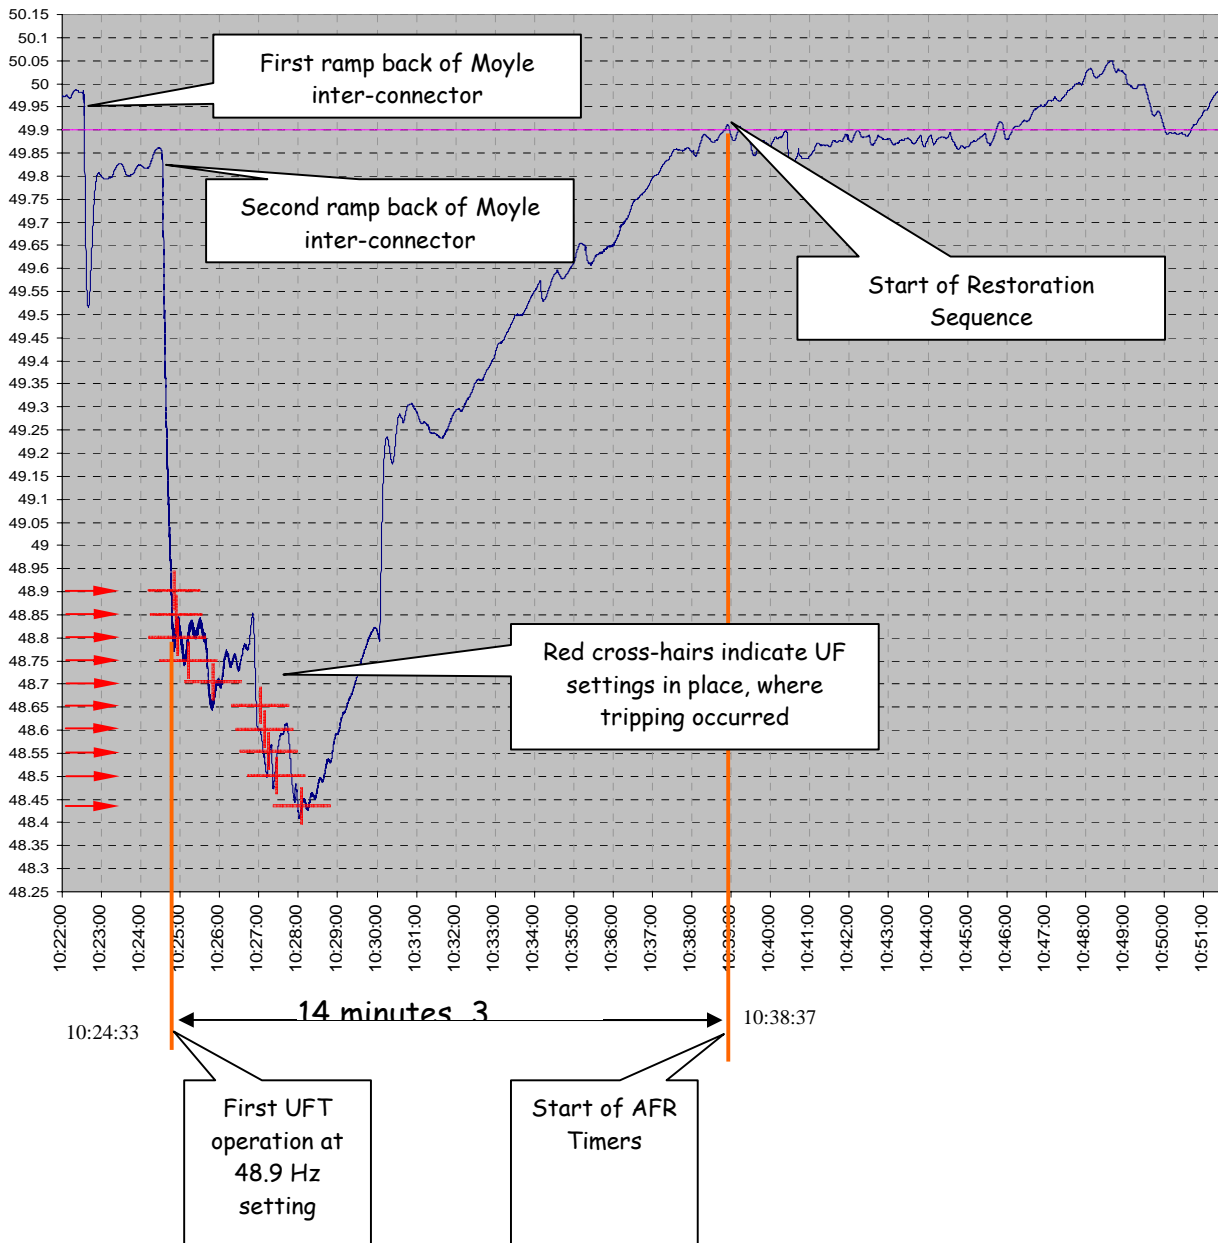
Frequency Trace 5-8-2005

- ❑ The recorded frequency nadir was 48.408. Hz
- ❑ Automatic Frequency Restoration [AFR] begins to time out at 49.9 Hz.

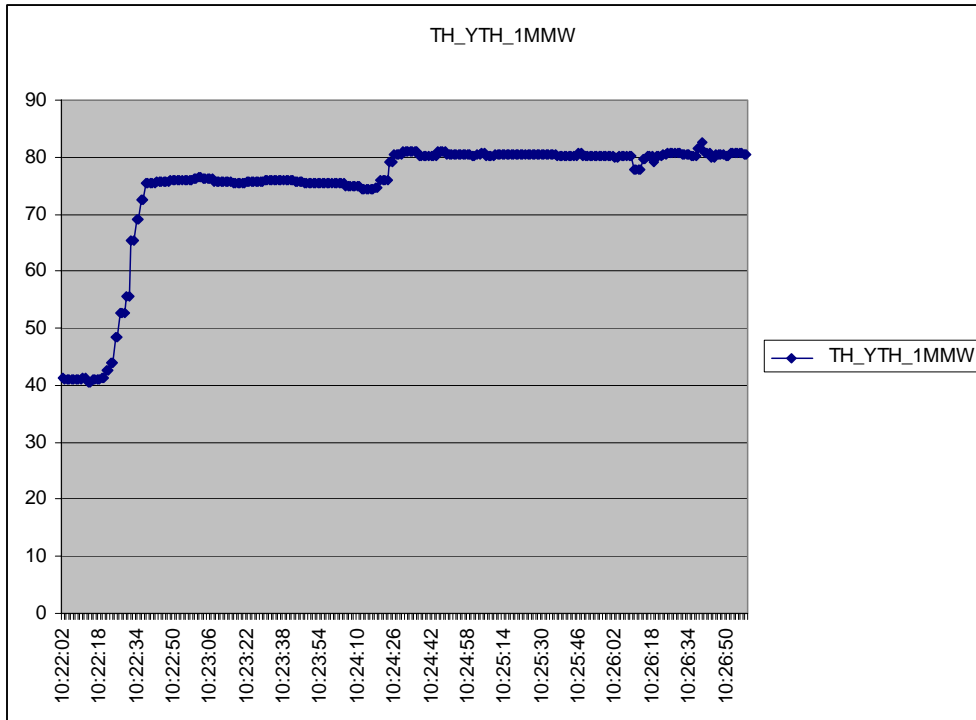
Output of Turlough Hill Unit 1 pumped storage generator during the event.

As can be seen from this graph, this unit rose automatically from 42.5 MW at 10.22.22 hrs to 75.4 MW by 10.22.40 and rose further to 80.9 MW in response to the second frequency drop. This unit has a name-plate rating of 73 MW.

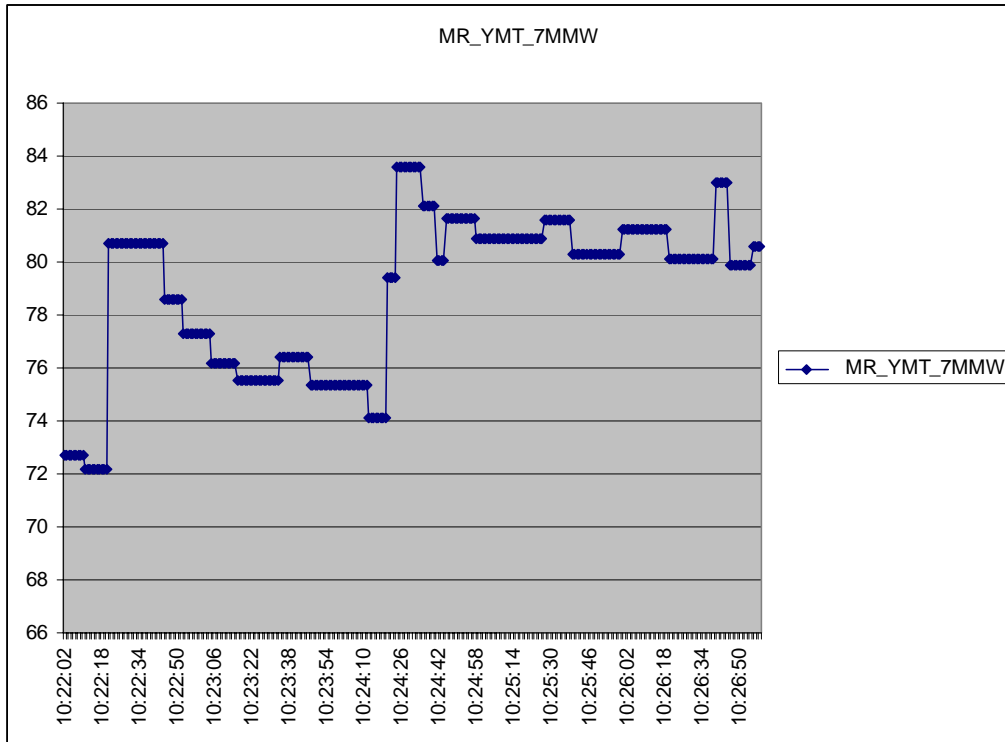
Output of Marina Combustion Turbine generator during the event.

As can be seen from this graph, this unit rose initially from 72 MW to 81 MW, delivering an inertial response. It had settled down to 74 MW prior to the second frequency drop when it delivered an inertial response to 84 MW. It then levelled out at 80 MW, 8 MW above its pre-event output.

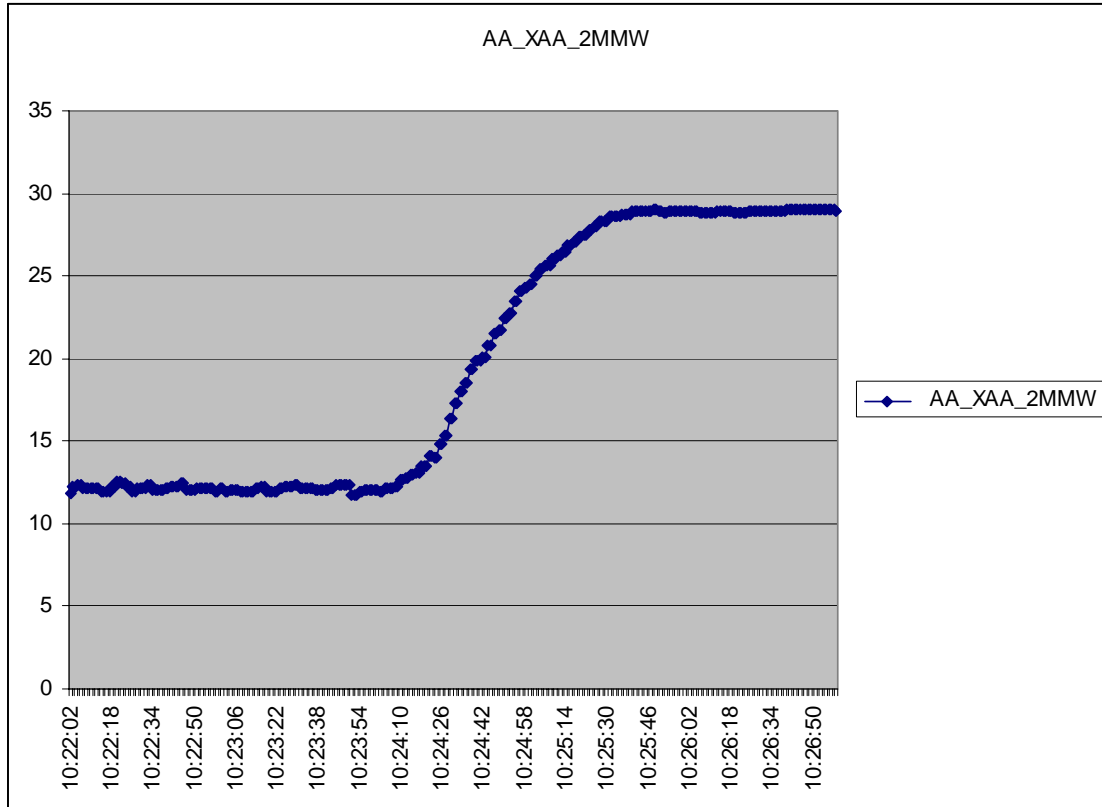
Output of Ardnacrusha Unit 2 hydro generator during the event.

This unit rose initially from 12.5 MW pre-fault to 29 MW.

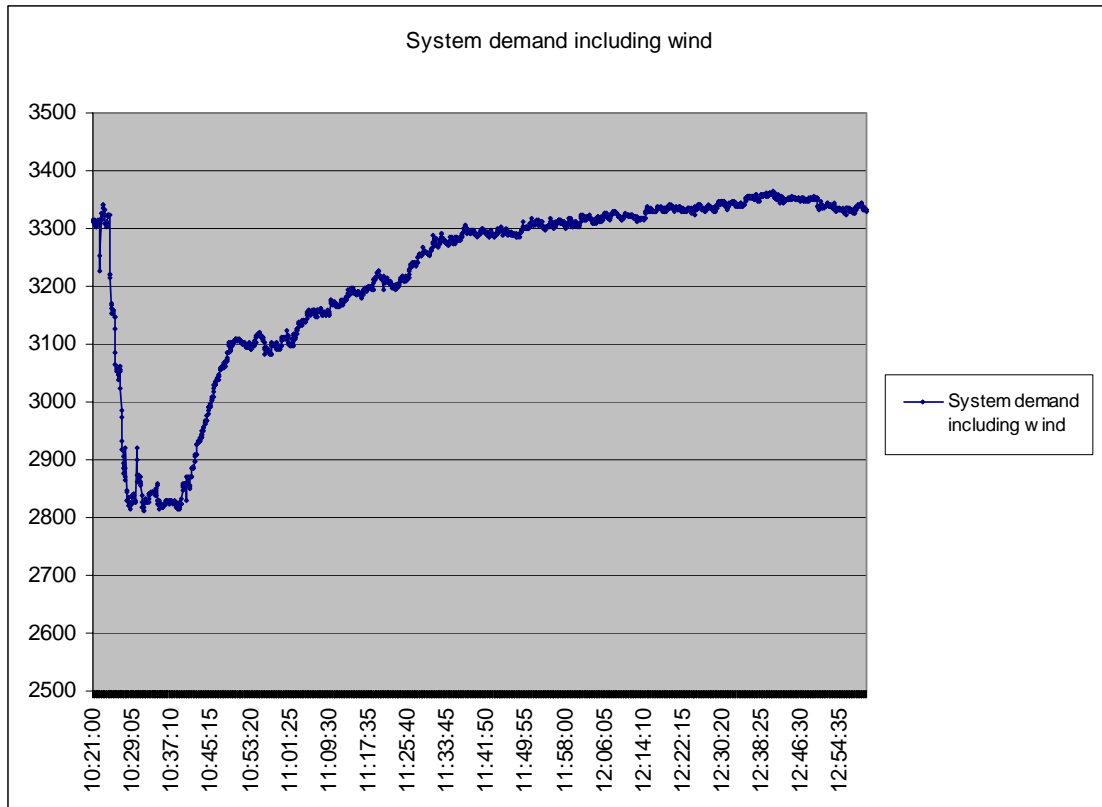
The graph above plots the variation in system demand during the event. As can be seen, load shedding of 500 MW approximately occurred.
